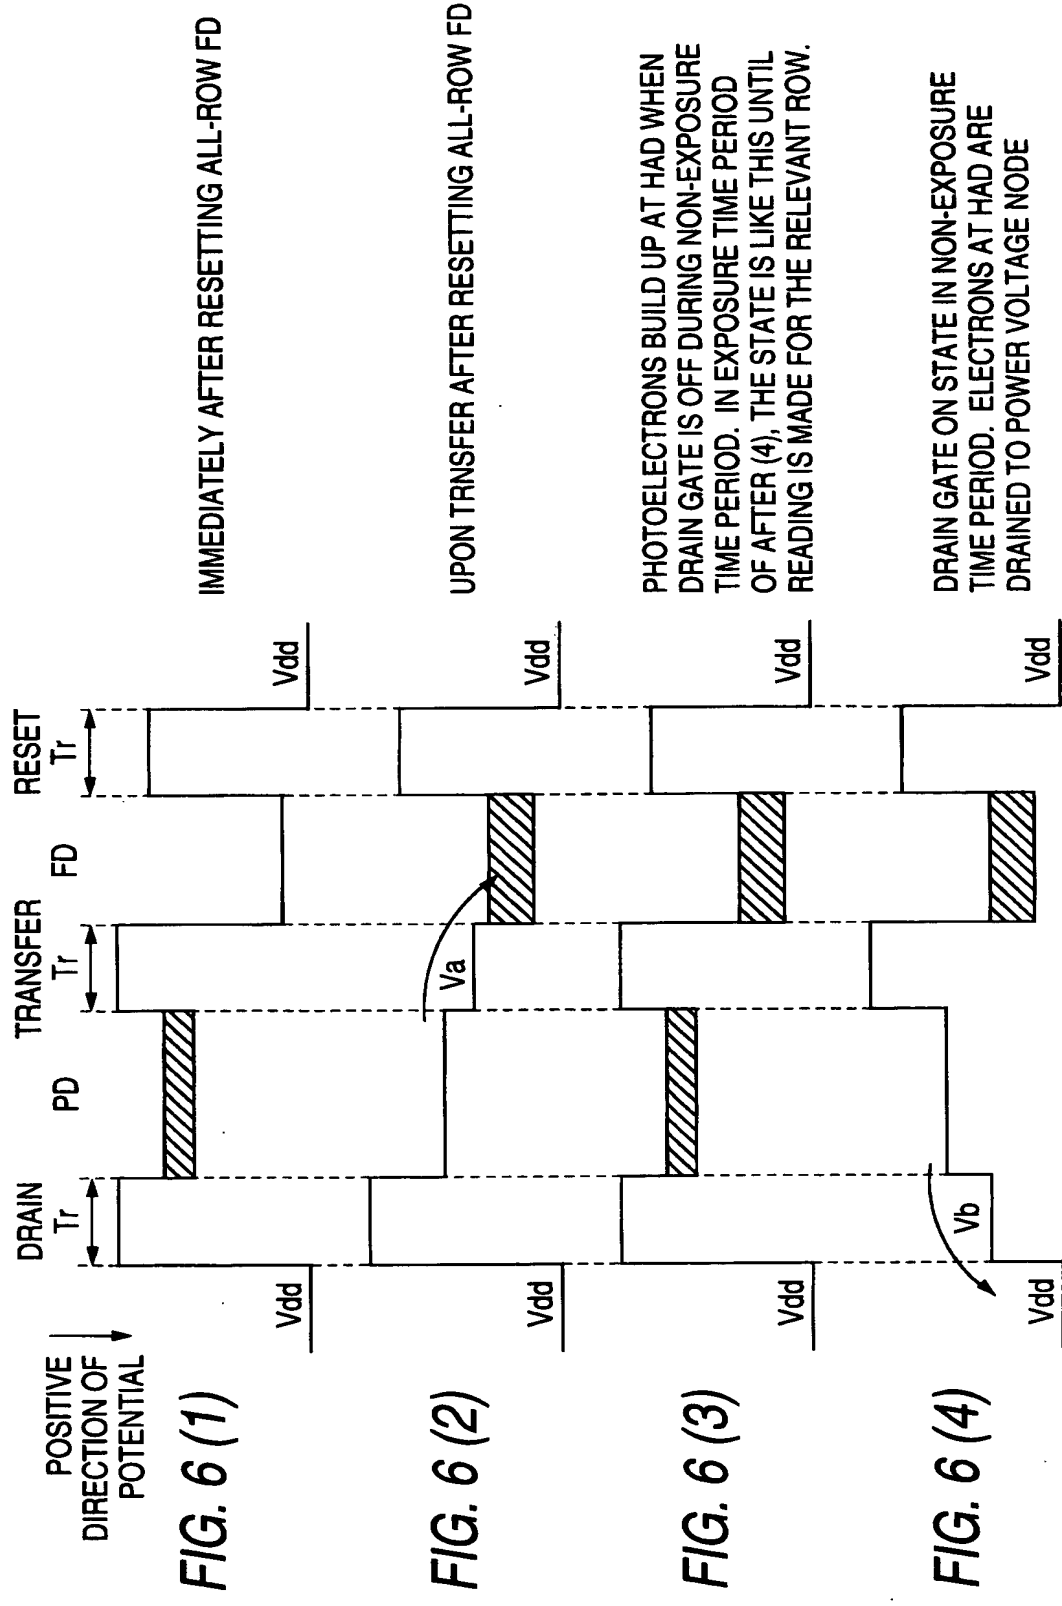
BECAUSE HAD, IN STATE, CAN RETURN TO THE SAME STATE AS (2), THERE IS NO IMAGE DETERIORATION EVEN IF DRAIN GATE CHARACTERISTIC IS DIFFERENT FROM TRANSFER GATE CHARACTERISTIC. IN THE FIGURE, V_a AND V_b ARE DIFFERENT IN VALUE.

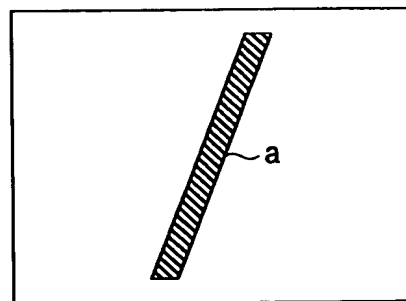
FIG. 7C

PHOTOGRAPHIC IMAGE
WHEN SHOOTING
VERTICALLY STRAIGHT
OBJECT MOVING SIDEWAYS

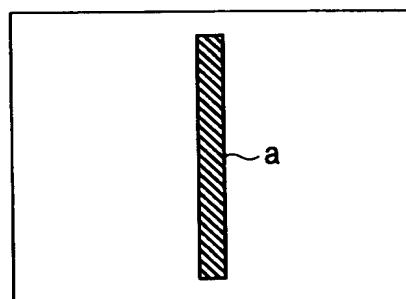
FIG. 7D

PHOTOGRAPHIC IMAGE
WHEN SHOOTING
VERTICALLY STRAIGHT
OBJECT MOVING SIDEWAYS
